Damage mechanisms in cementitious coatings on steel members in bending

Usmani, A, Chen, S, Jiang, L & Li, G-Q 2014, 'Damage mechanisms in cementitious coatings on steel members in bending', *Structures and Buildings*. <https://doi.org/10.1680/stbu.13.00096>

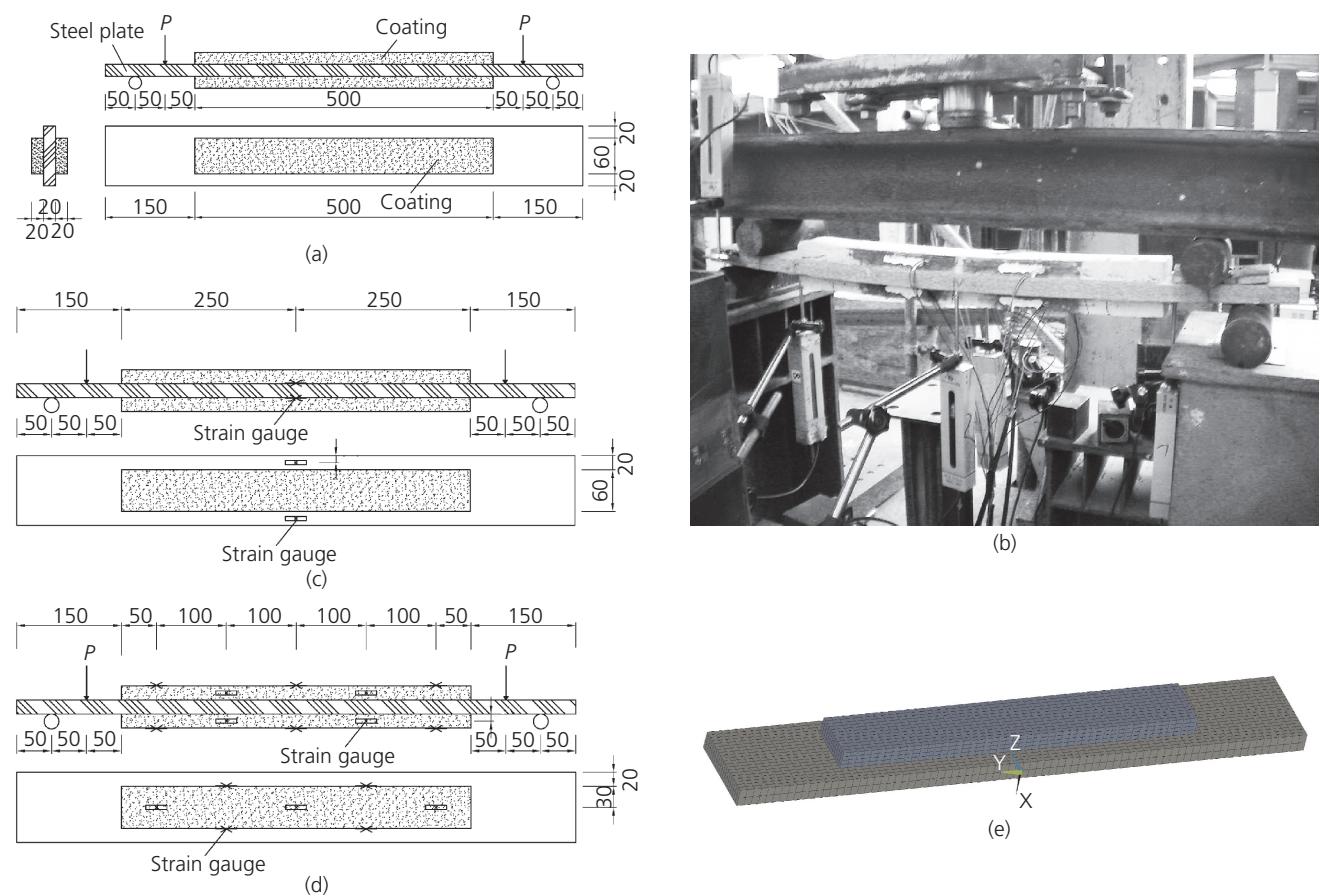
Figure 1. Set-up of beam test and finite-element model:
(a) dimension of specimen; (b) photo of beam test; (c) strain gauge on steel; (d) strain gauge on coating; (e) finite-element model

Pure bending loads are applied on the cementitious material coated steel members to investigate the correlation of damage in the coating with the strains and curvatures in the steel members. To ensure that the insulated plate is in pure bending and to avoid more complex stress states, the test set-up is designed as shown in Figures 1(a) and 1(b), where the insulated length L is 500 mm, the width W is 60 mm and the thickness T is 20 mm. The specimens tested are listed in Table 1. All the steel plates in tests are of the same size of 800 mm \times 100 mm \times 20 mm, as shown in Figure 1(a). The measurements include central deflection and strains on top and bottom surfaces of steel plate. Because the glues used for installing strain gauges significantly affect the coating's stiffness and strength, only two specimens have been installed with strain gauges on the coatings. The installation of strain gauges is shown in Figure 1(c) and Figure 1(d).

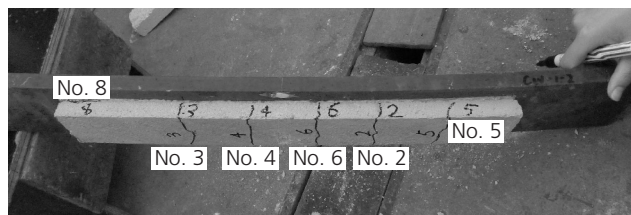
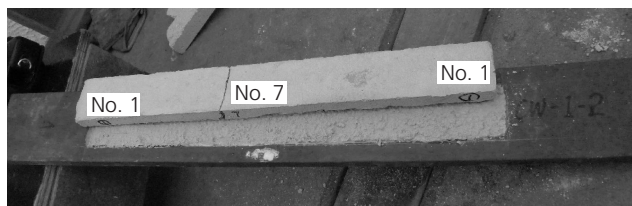
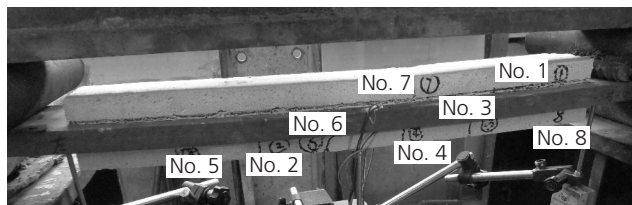
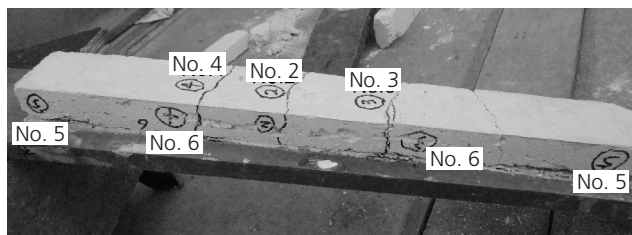
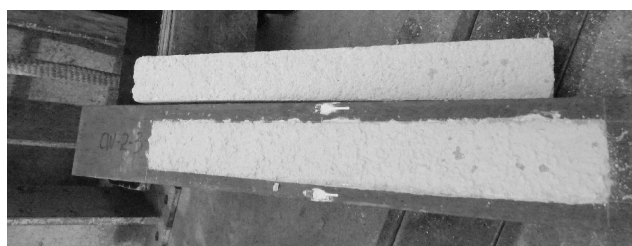
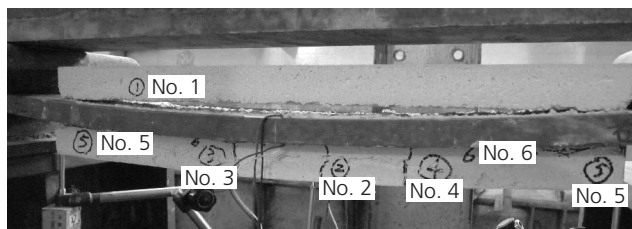
Figure 2. Failure modes of specimens: (a) fracture of coating on tension side of CW1-2; (b) shear fracture on compression side of CW1-2; (c) failure mode of CW1-2; (d) fracture of coating on tension side of CW2-3; (e) peeling off of the coating on compression side of CW2-3; (f) failure mode of CW2-3

For the case of the 20-mm-thick coating, when the curvature in the neutral plane reaches $0.67 \times 10^{-4} \text{ mm}^{-1}$, interfacial cracks (number 1 in Figures 2(b) and 2(c)) are observed at both ends on the compression side and are observed to propagate towards the centre. When the curvature reaches $0.91 \times 10^{-4} \text{ mm}^{-1}$, the first transverse

crack (number 2 in Figure 2(a)) occurs on the tension side. With further increase in loading, more transverse cracks occur on the tension side (numbers 3–6 and 10, shown in Figures 2(a) and 2(c)) and shear induced fracturing (number 7 shown in Figures 2(b) and 2(c)) on the compression side are observed. The reason for shear fracture on the compression side is the effect of curvature, which induces shear and bending stresses in the delaminated parts of the

For the case of 30-mm-thick coating (shown in Figures 2(d)–2(f)), a similar phenomenon is observed except that no shear

fracture on the compression side is observed and cracks initiate earlier. The curvatures for the first interfacial crack and first transverse crack are about $0.2 \sim 0.3 \times 10^{-4} \text{ mm}^{-1}$ and $0.3 \sim 0.4 \times 10^{-4} \text{ mm}^{-1}$ respectively. The thicker coating causes higher bond stresses and induces earlier occurrence of damage and more severe interfacial damage.

The damage mechanism and damage propagation from the simulation agrees well with the test results as shown in Figure 2(a), although differences exist in the correlation of curvatures to different damage states.

From Table 5 and Figures 14 and 15, it is noted that increasing the coating thickness causes an earlier (at lower curvatures) occurrence of interfacial and transverse cracks, and an earlier failure, as well as the change of the damage mechanism. The earlier occurrence of cracking can also be observed in Figure 16. The key reason for this is that increasing the coating thickness increases the bond stresses (both normal and tangential). From Figures 16(a) and 16(b), the 40-mm-thick coating already has an interfacial crack at both ends, at curvatures for which no cracks occur for 20 mm and 30 mm coating thicknesses. The damage mechanism may also change with thickness. In the 20-mm- and 30-mm-thick coatings on the tension side, transverse cracks are observed. But there are no transverse cracks for the 40-mm-thick coating. For the 20-mm-thick coating on the compression side, through-thickness shear fractures occur due to the effect of curvature. Nevertheless, no through-thickness shear fracture is observed for cases of 30 mm and 40 mm. The effect of thickness has also been observed in tests (Figure 2, Table 1).

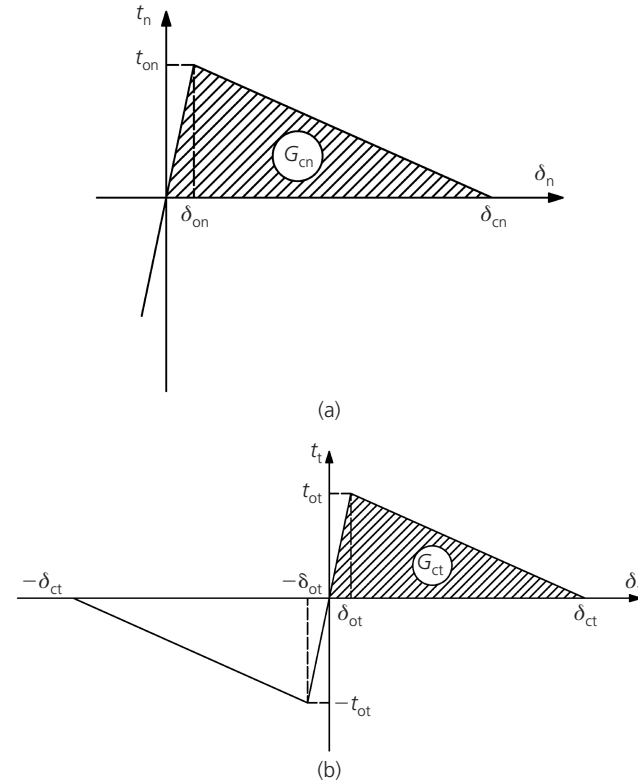
Figure 3. Uncoupled constitutive relationships: (a) normal direction; (b) tangential direction

The constitutive law corresponding to Figure 3 can be expressed from a damage mechanics perspective as

ϕ_α is applied to describe the stiffness degradation due to interfacial damage. Correspondingly damage parameter d_α is defined by Equation 3. A zero value of d_α represents the undamaged elastic interface, while $d_\alpha = 1$ indicates that the interface is fully damaged.

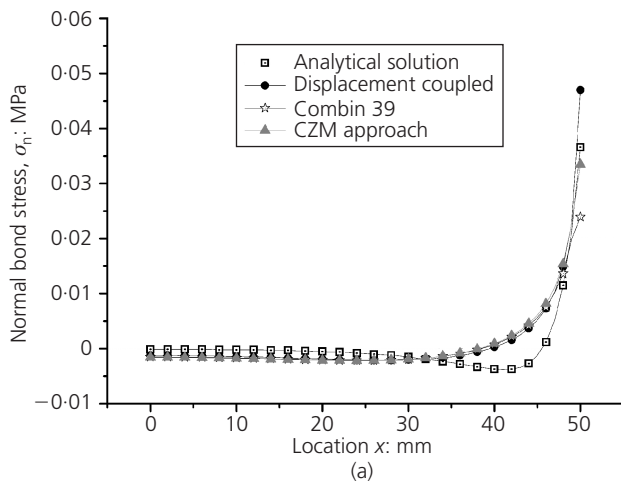
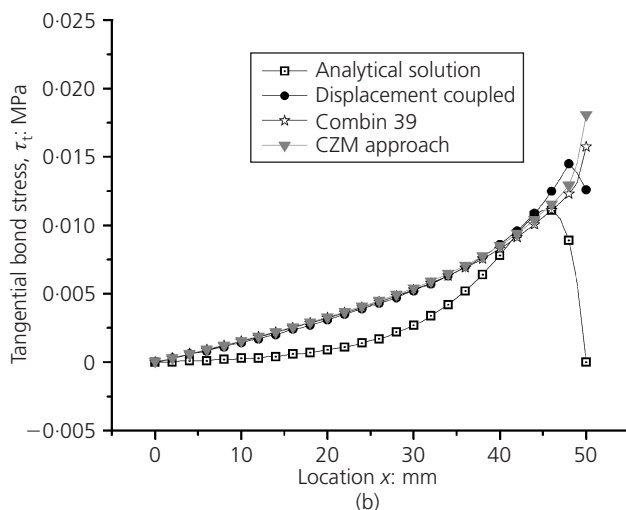
Figure 4. Comparison of interfacial (bond) stresses for axially loaded case: (a) normal direction; (b) tangential direction

From Figure 4(a), normal interfacial (bond) stress curves are generally of the same shape with maximum normal interfacial stress located at the very end of the interface; however, differences can be seen near the end (40~50 mm) of the interface. It is noticed that there is a 10 mm (35~45 mm) compressive (negative) zone for the analytical solution, but all the numerical approaches did not capture this phenomenon, which is due to the chosen discretisation and can be improved with a finer mesh. However, since negative normal bond stress will not cause debonding and affect the damage mode, it was considered acceptable to retain the chosen mesh.

end of the interface, as plotted in Figure 4(b). For the analytical solution, the interfacial stress drops to zero at the end. However, boundary conditions could not be precisely satisfied in finite-element analyses given the continuity limitation of displacement shape functions and the presence of a singularity at the corner of the coating–steel interface. A finer mesh may help but cannot fundamentally solve this problem.

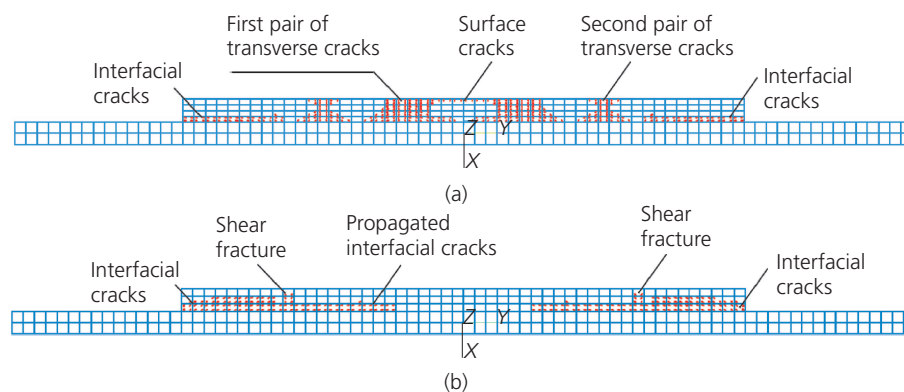
Figure 5. Damage mechanism of cementitious coating on steel member in bending: (a) tension side; (b) compression side

The coatings on the tension side and the compression side show different damage mechanisms (Figure 5), which will be described in detail in the following subsections.

be represented using curvature and depth. The damage propagation has been detailed in Table 4 and the simulated damage mechanism is shown in Figure 5(a). The contact element status, contour plot of normal bond stress and the first principal stress in the coating are shown in Figures 6, 7 and 8 respectively. From Table 4 and Figures 6–8, the damage mechanisms can be clearly identified. When the curvature at the neutral plane reaches $0.37 \times 10^{-4} \text{ mm}^{-1}$, there is no damage. But when the curvature reaches $0.39 \times 10^{-4} \text{ mm}^{-1}$, cracks initiate at both ends of the interface (Figure 6(b) and Figure 7(b)), followed by the first pair of transverse cracks and surface cracks (Figure 7(c) and Figure 8(c)) at the curvature of $0.42 \times 10^{-4} \text{ mm}^{-1}$. The second pair of transverse cracks occurs at the curvature of $0.45 \times 10^{-4} \text{ mm}^{-1}$ (Figure 7(d) and Figure 8(d)). With further increase of curvature, the interfacial cracks propagate towards the centre, more transverse cracks occur (Figure 7(e) and Figure 8(e)) and centre cracks

The same finite-element model has been adopted to simulate damage propagation in the cementitious coating on the compression side. Figure 5(b) shows the simulated damage mechanism, which is explained in Table 4 and Figures 11–13. When the curvature at the neutral plane reaches $1.056 \times 10^{-4} \text{ mm}^{-1}$, there is no damage. When the curvature reaches $1.063 \times 10^{-4} \text{ mm}^{-1}$, damage initiates at both ends of interface (Figure 11(a)), and then interfacial cracks occur at both ends (Figure 12(a) and Figure 12(c)). With a further increase of curvature, the interfacial cracks propagate towards the centre (Figures 11(c) and 11(d),

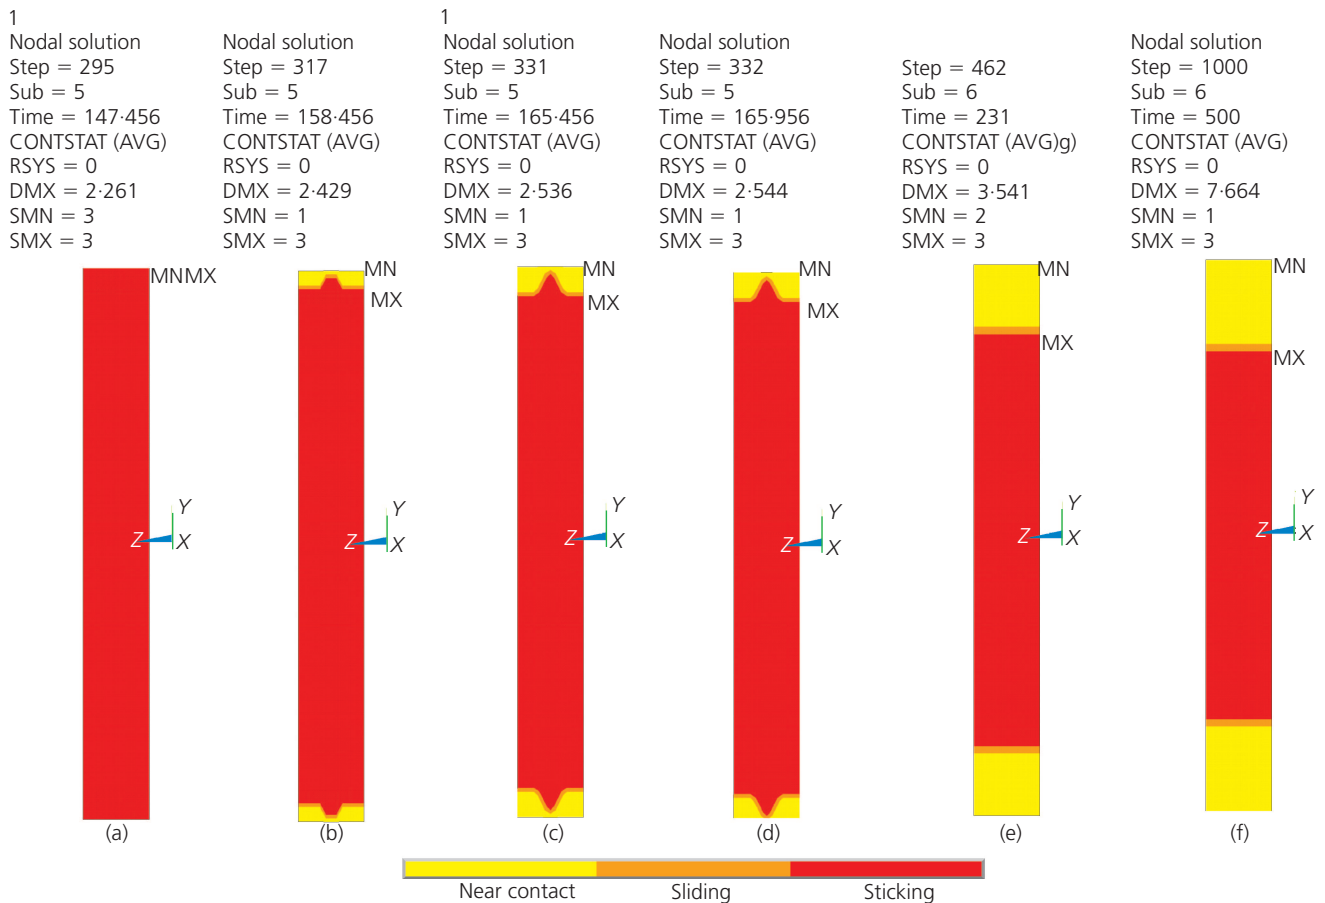
Figure 6. Contact element status at different steel curvature on tension side (ϕ_s ; mm^{-1}): (a) 0.37×10^{-4} ; (b) 0.39×10^{-4} ; (c) 0.42×10^{-4} ; (d) 0.45×10^{-4} ; (e) 0.58×10^{-4} ; (f) 1.26×10^{-4}

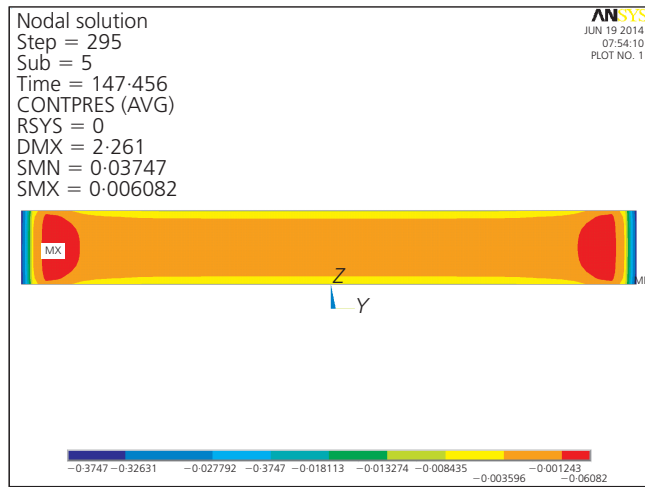
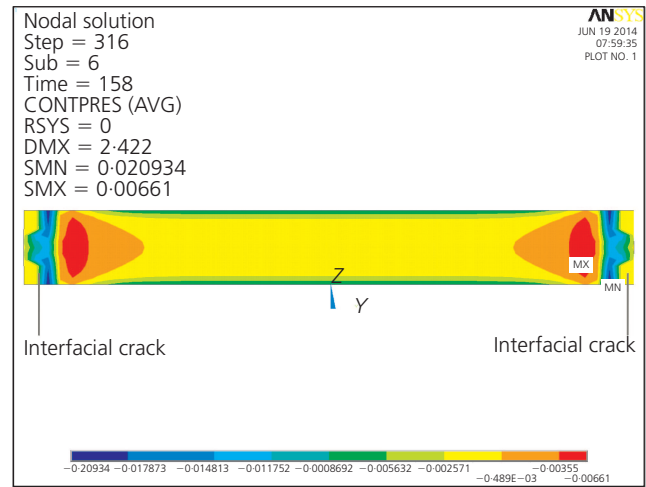
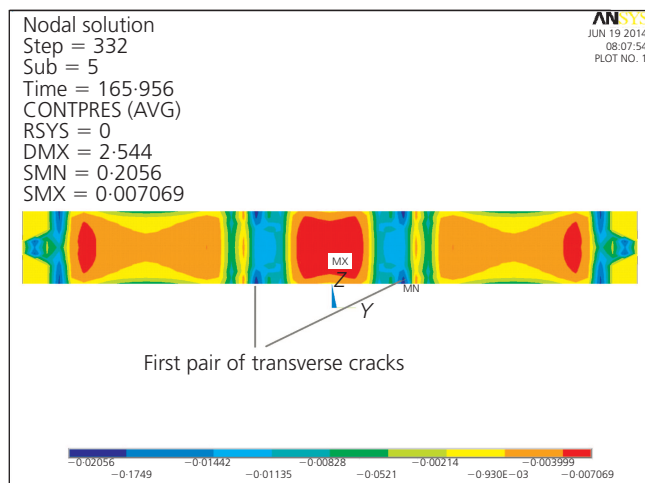
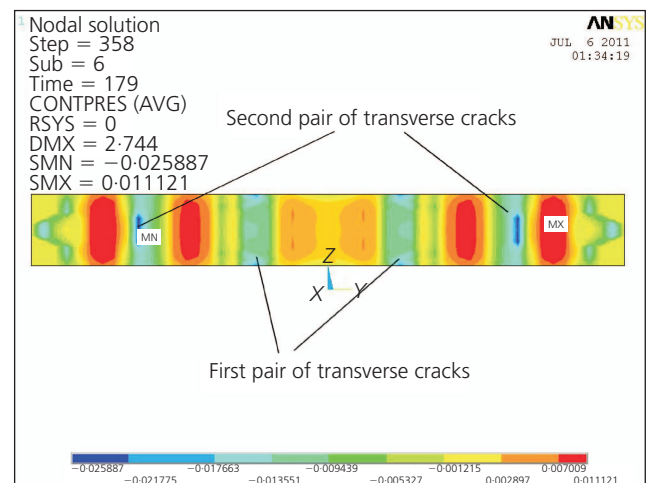
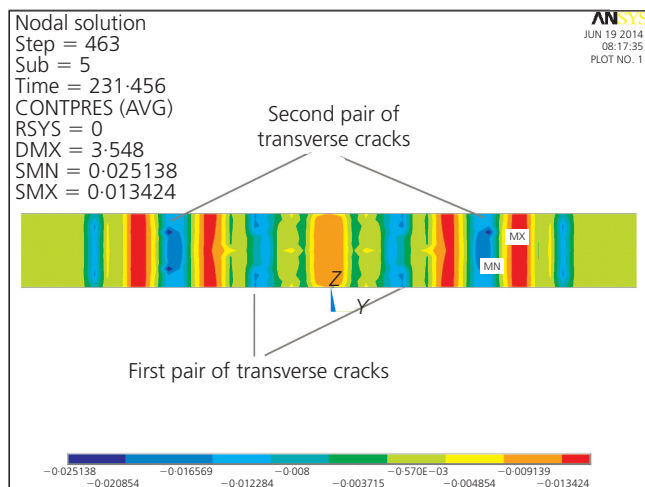
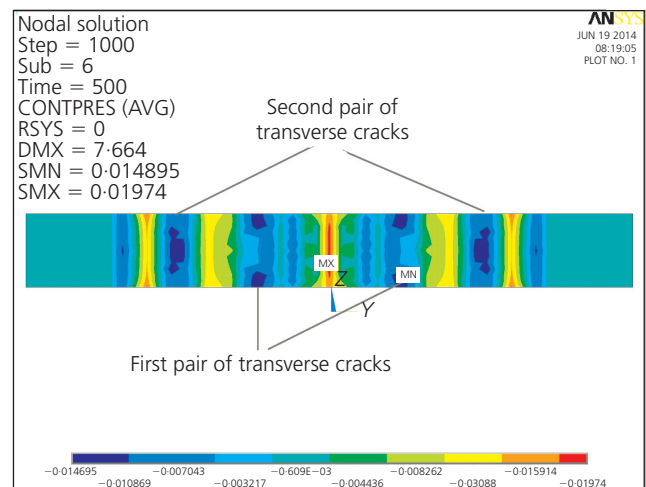
Figure 7. Contour plot of normal bond stress at different steel curvature on tension side (ϕ_s : mm^{-1}): (a) 0.37×10^{-4} ; (b) 0.39×10^{-4} ; (c) 0.42×10^{-4} ; (d) 0.45×10^{-4} ; (e) 0.58×10^{-4} ; (f) 1.26×10^{-4}

at the top surface occur at the late period (Figure 7(f) and Figure 8(f)). The final failure mode is that the coating fractures into several segments with delamination at both ends. Compared to the damage mechanisms observed in cementitious coatings on axially loaded steel members in tension, the coating on the tension side in bending undergoes more severe interfacial damage with longer and larger delamination, as well as the occurrence of surface cracks.

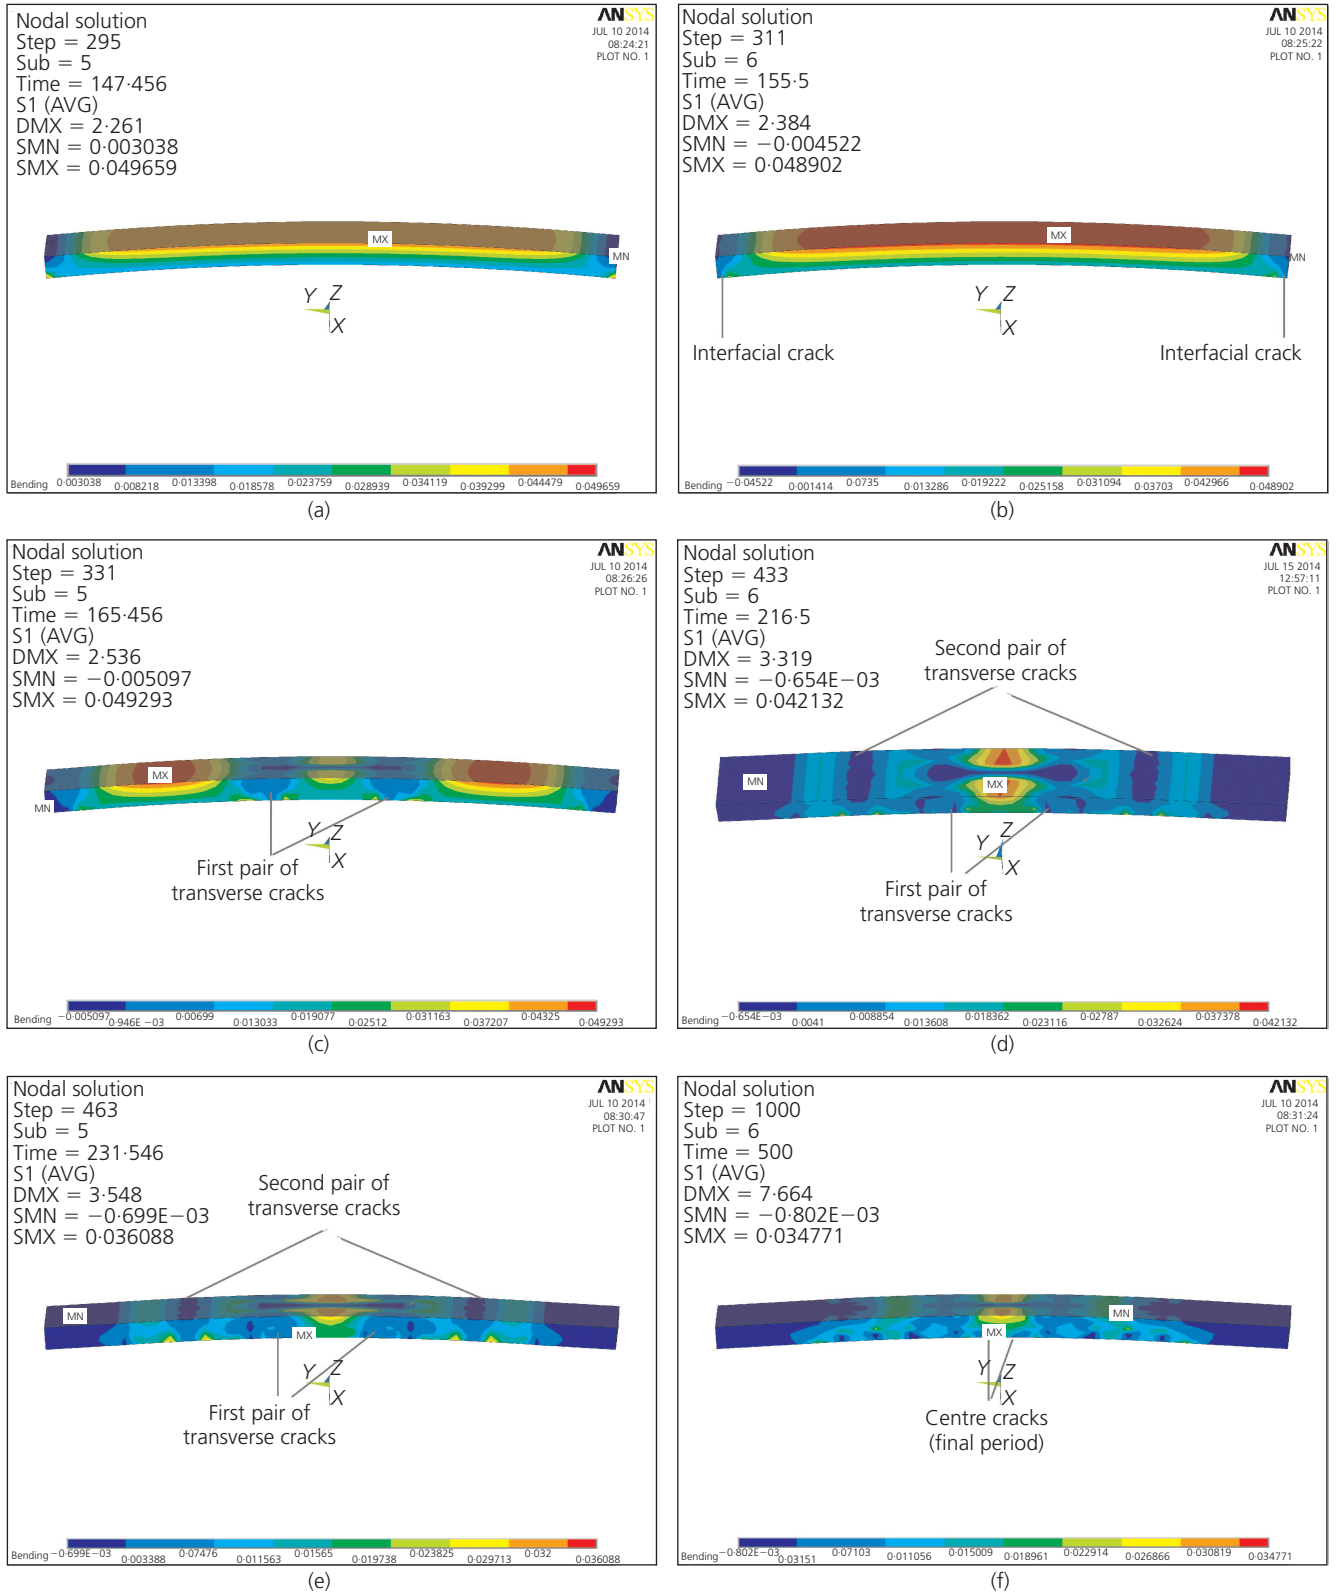
Figure 8. Contour plot of first principal stress in coating at different steel curvature on tension side (ϕ_s ; mm^{-1}):

- (a) 0.37×10^{-4} ; (b) 0.39×10^{-4} ; (c) 0.42×10^{-4} ;
(d) 0.45×10^{-4} ; (e) 0.58×10^{-4} ; (f) 1.26×10^{-4}

location of the crack drops from its maximum value to zero once the crack occurs. The difference between the centre parts of Figure 9(c) and Figure 9(d) for curvatures of $0.415 \times 10^{-4} \text{ mm}^{-1}$ and $0.448 \times 10^{-4} \text{ mm}^{-1}$ denotes the occurrence of non-through-thickness transverse cracks starting from the top surface, as the first principal stress at the top surface drops from its maximum value to zero, but no drop is observed for the first principal stress at the surface 5 mm below (shown in Figures 7(f) and 8(f)). This non-through-thickness crack is caused by the effect of curvature.

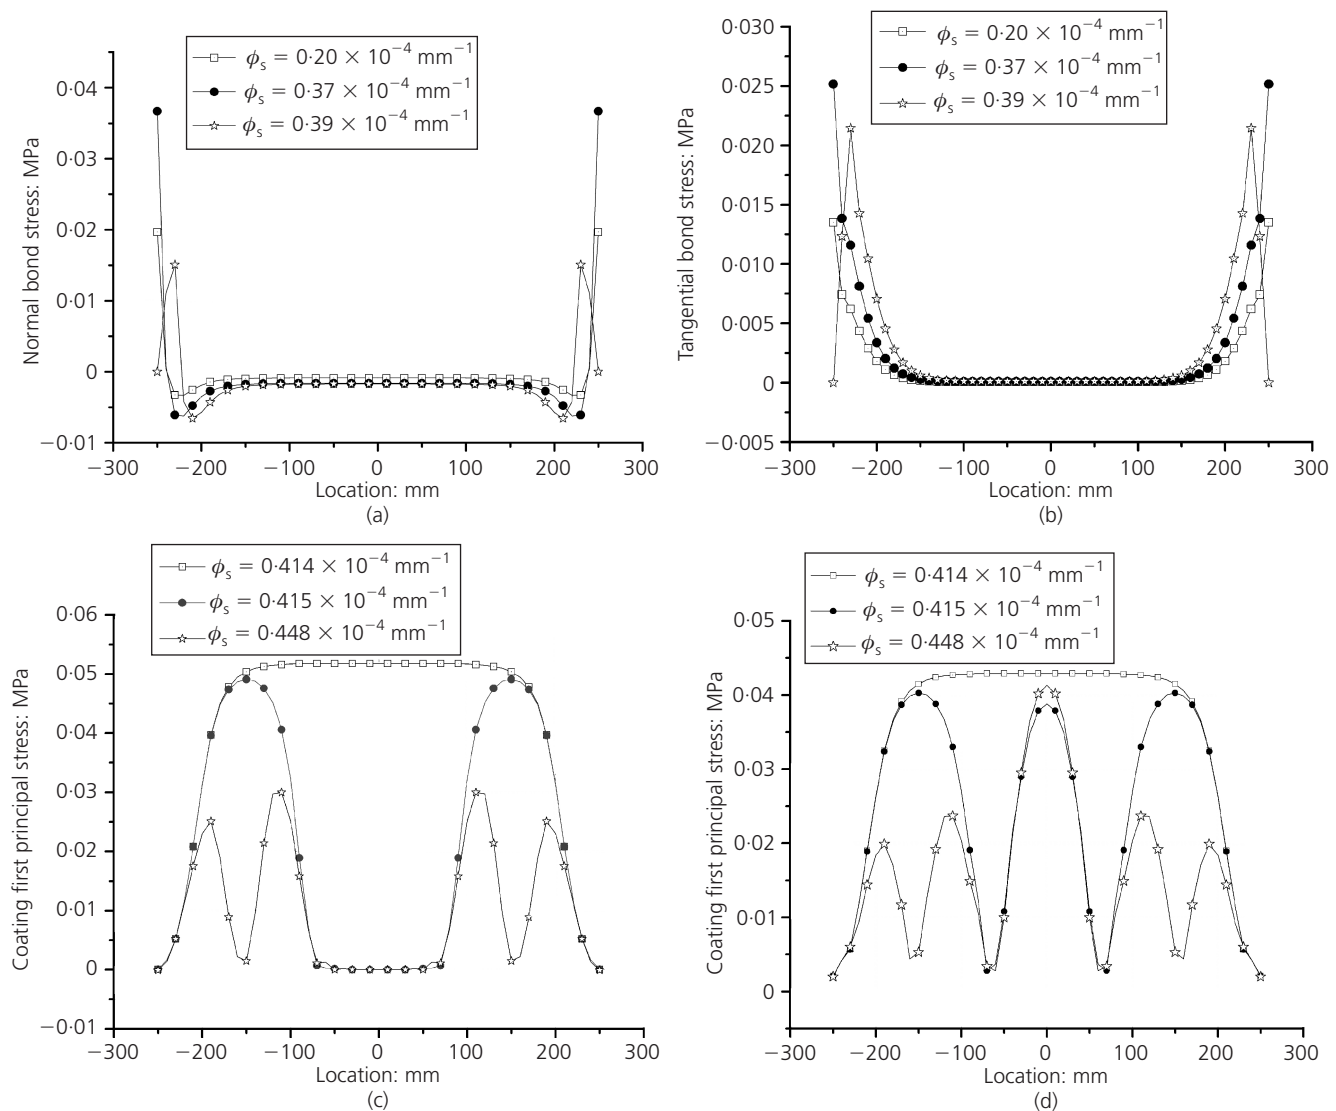
Figure 9. Stress distribution along the axis at different steel curvature on tension side: (a) normal direction; (b) tangential direction; (c) first principal stress of coating at top surface;

(d) first principal stress of coating at the surface 15 mm above the interface

Interfacial cracking can also be detected from Figure 9(a) and Figure 9(b). When the curvature increases from $0.37 \times 10^{-4} \text{ mm}^{-1}$ to $0.39 \times 10^{-4} \text{ mm}^{-1}$, both the normal bond stress and tangential bond stress at the ends drop from maximum values to zero, which indicates the occurrence of delamination. The occurrence of transverse cracks can be detected from Figure 9(c), Figure 9(d) and Figure 10, as the first principal stress at the

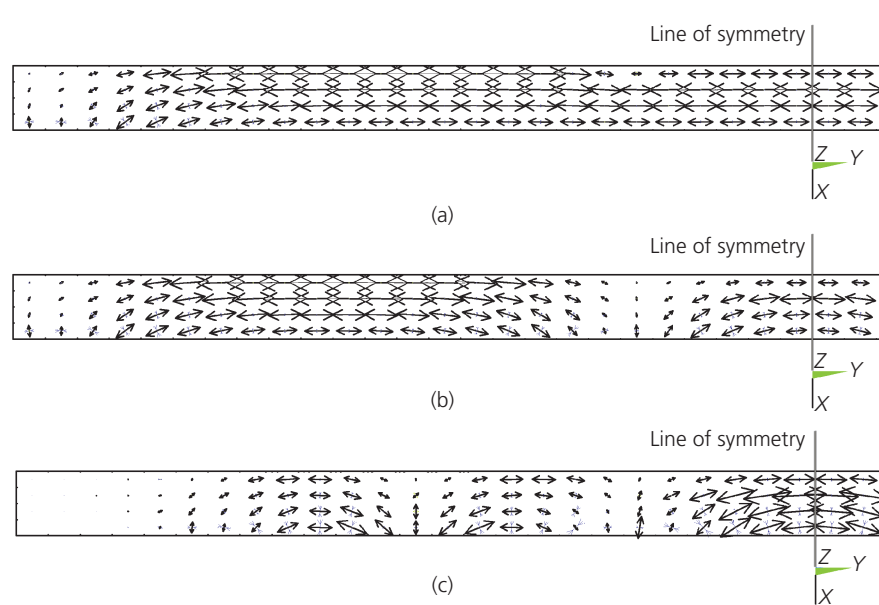
Figure 10. Propagation of first principal stress vector plot of half coating considering symmetry on tension side (ϕ_s : mm^{-1}):
(a) 0.414×10^{-4} ; (b) 0.415×10^{-4} ; (c) 0.448×10^{-4}

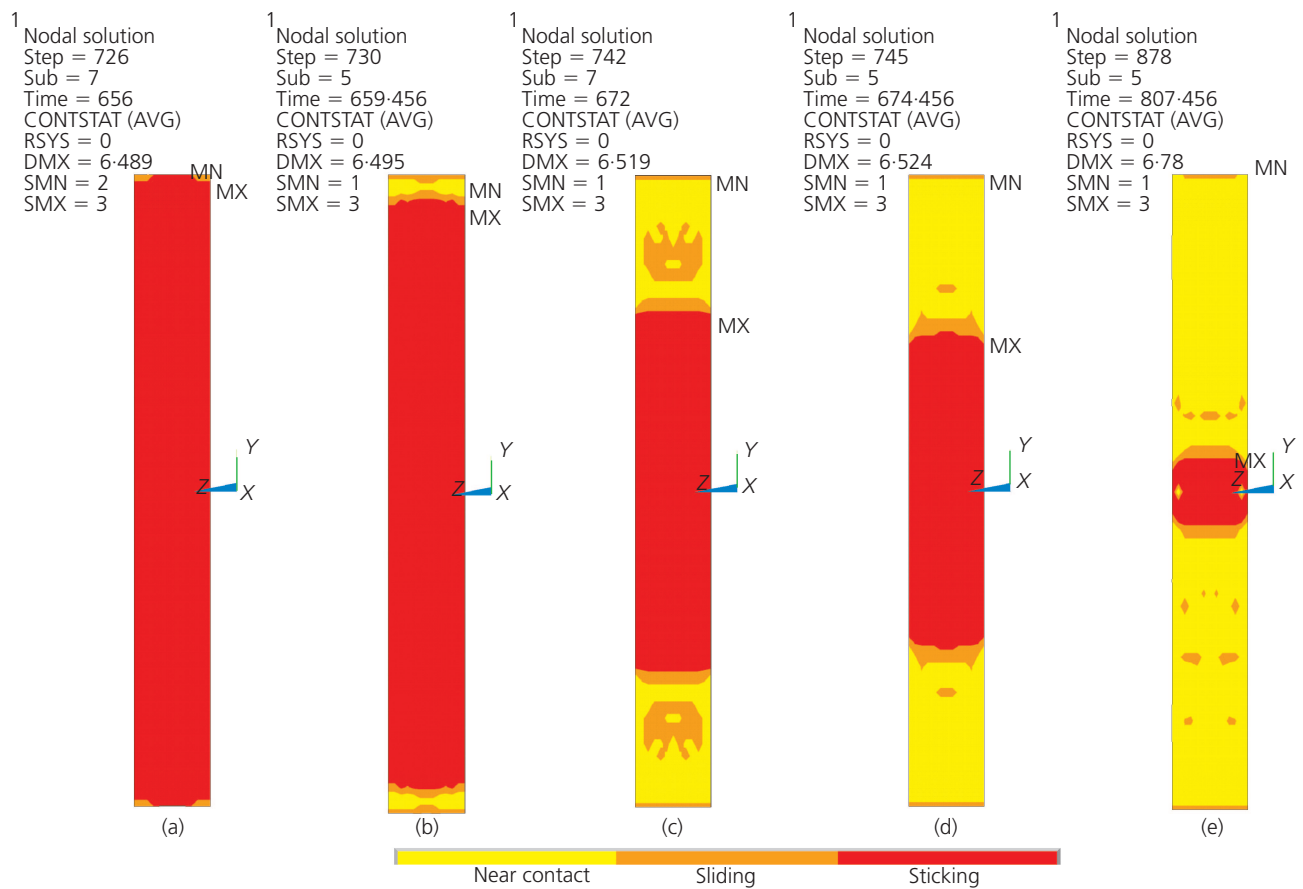
Figure 11. Contact element status at different steel curvature on compression side (ϕ_s : mm^{-1}): (a) 1.063×10^{-4} ; (b) 1.064×10^{-4} ; (c) 1.068×10^{-4} ; (d) 1.069×10^{-4} ; (e) 1.112×10^{-4}

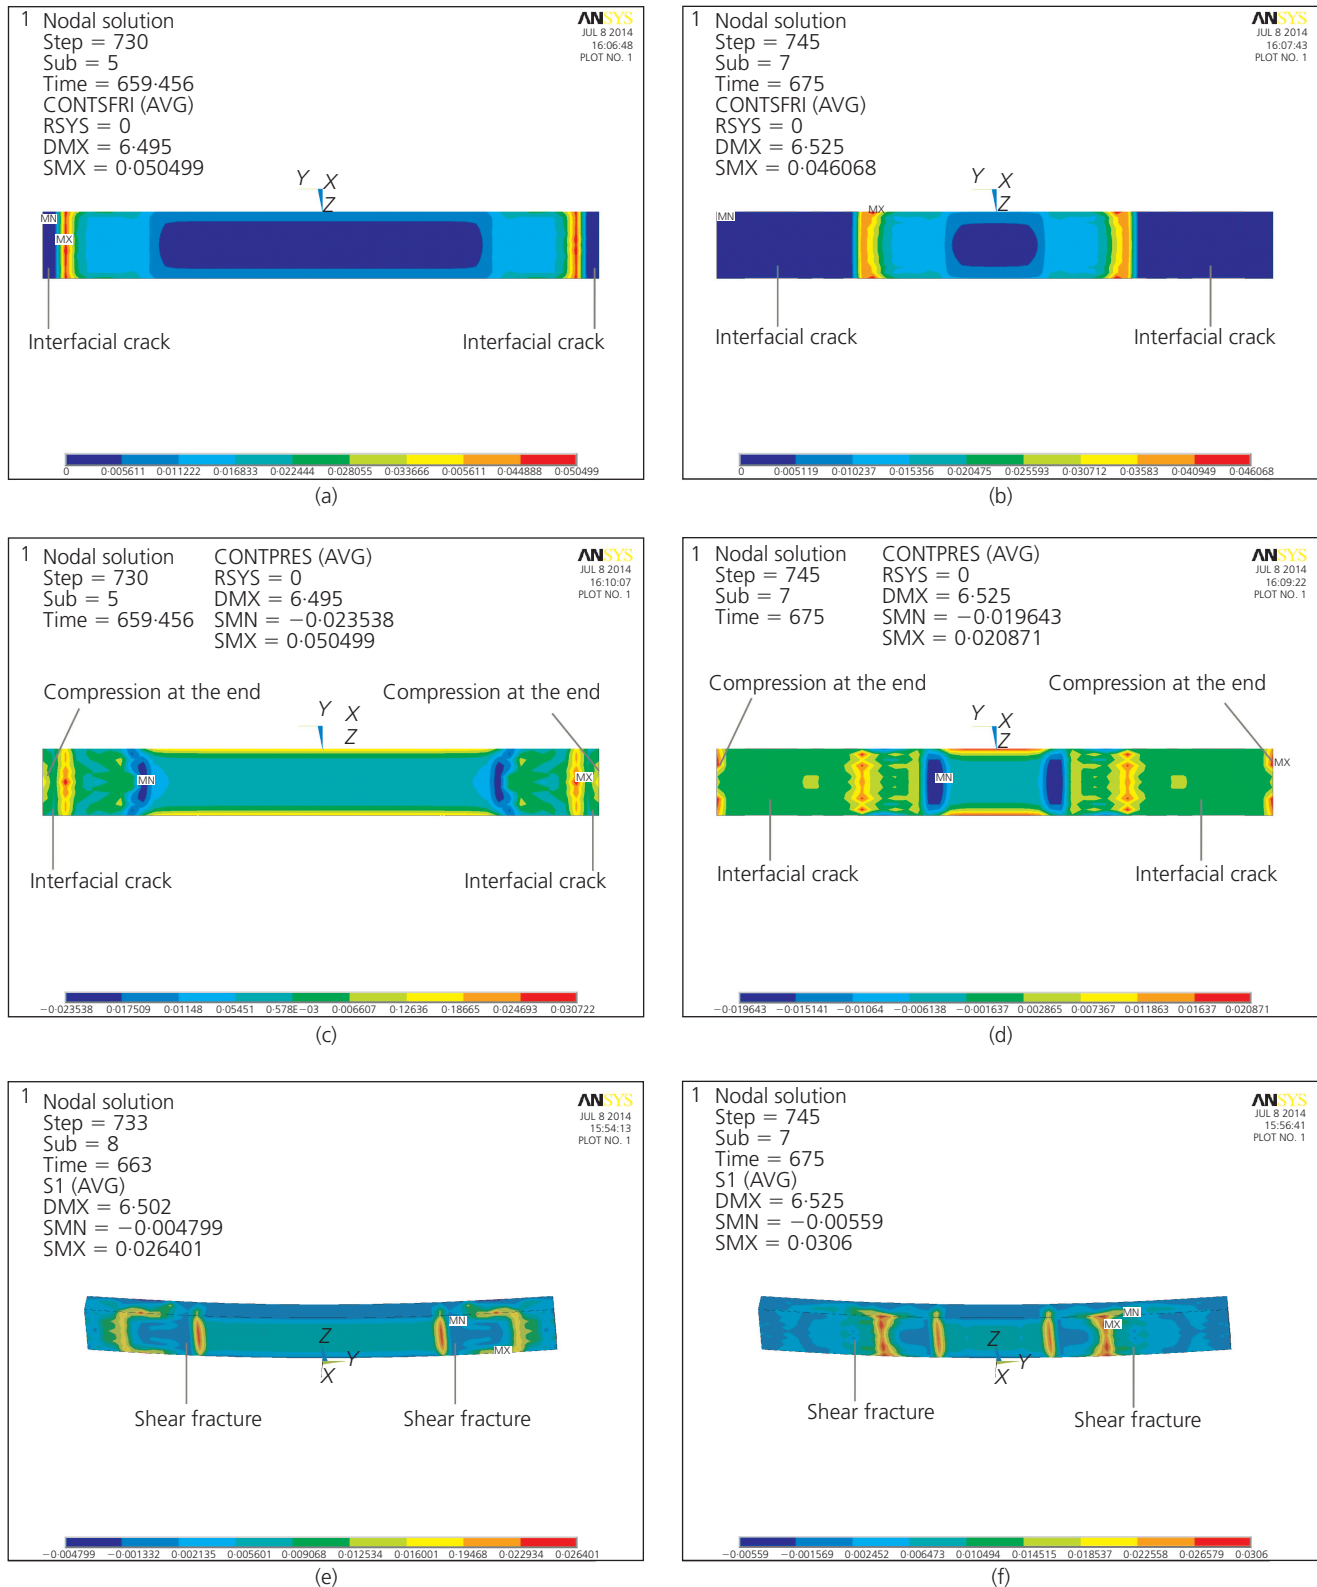
Figure 12. Contour plot of stress at different steel curvature on compression side (ϕ_s : mm^{-1}): (a) tangential bond stress (1.064×10^{-4}); (b) tangential bond stress (1.069×10^{-4}); (c) normal bond stress (1.064×10^{-4}); (d) normal bond stress (1.069×10^{-4}); (e) first principal stress (1.064×10^{-4}); (f) first principal stress (1.069×10^{-4})

Figure 12(b) and Figure 12(d)) and shear fractures occur when the curvature reaches $1.064 \times 10^{-4} \text{ mm}^{-1}$ (Figure 12(e)). The shear fracture is caused by the moment from the uplifting force at the end due to the effect of curvature. The damage mechanism and damage propagation observed from simulation agrees well with the test results, as shown in Figure 2(b), although the correlation of curvature with different damage states is not exactly the same. The effect of curvature in bending makes this behaviour somewhat different from the damage mechanisms observed in cementitious coatings on axially loaded steel members in compression, where only delamination damage is observed.

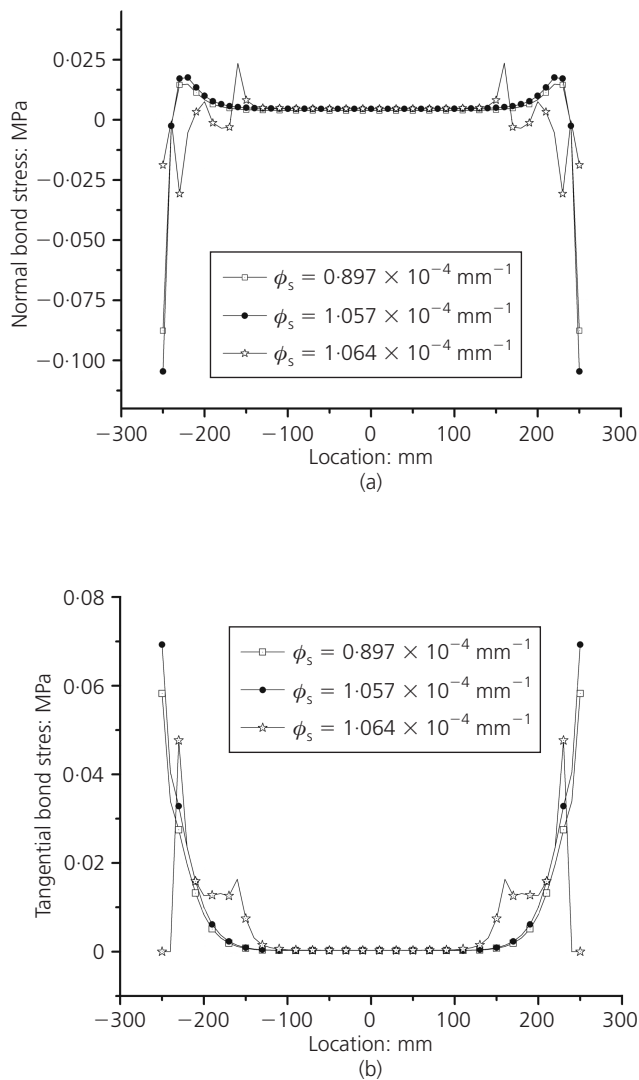
Figure 13. Bond stress distribution along the axis at different steel curvature on compression side (a) normal direction; (b) tangential direction

Initiation of interfacial cracks can be seen in Figure 13. When the curvature increases from $1.057 \times 10^{-4} \text{ mm}^{-1}$ to $1.064 \times$

10^{-4} mm^{-1} , a sharp change can be observed in the distributions of both the normal and tangential bond stresses, where the maximum values at both ends drop to zero, indicating failure of the bond.

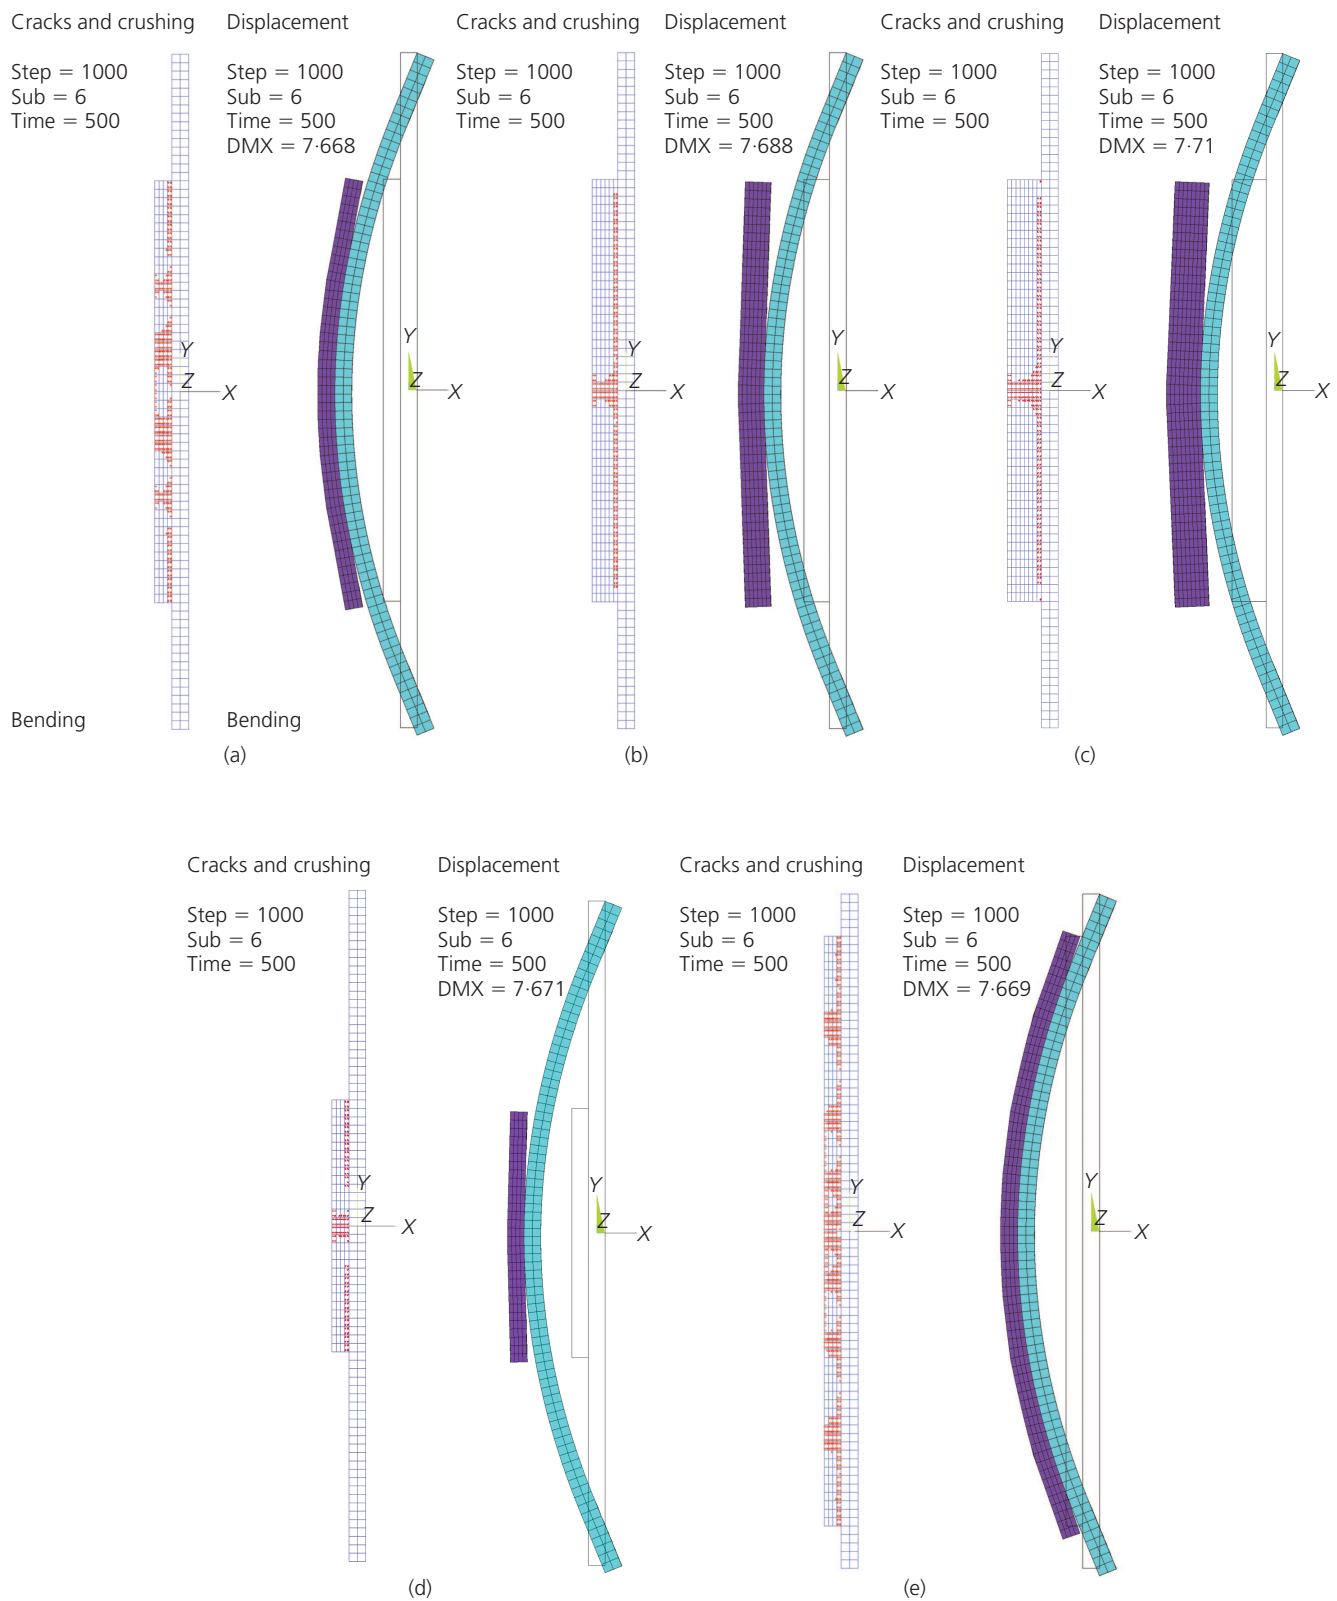
Figure 14. Comparison of damage mechanisms and final deformed shapes of different cases on tension side:
(a) $500 \times 60 \times 20$; (b) $500 \times 60 \times 30$; (c) $500 \times 60 \times 40$;
(d) $300 \times 60 \times 20$; (e) $700 \times 60 \times 20$

different thicknesses are compared in Table 5 for the tension side and compression side. The damage mechanisms found for different thicknesses and lengths of coatings on the tension and compression side are shown in Figure 14 and Figure 15, respectively.

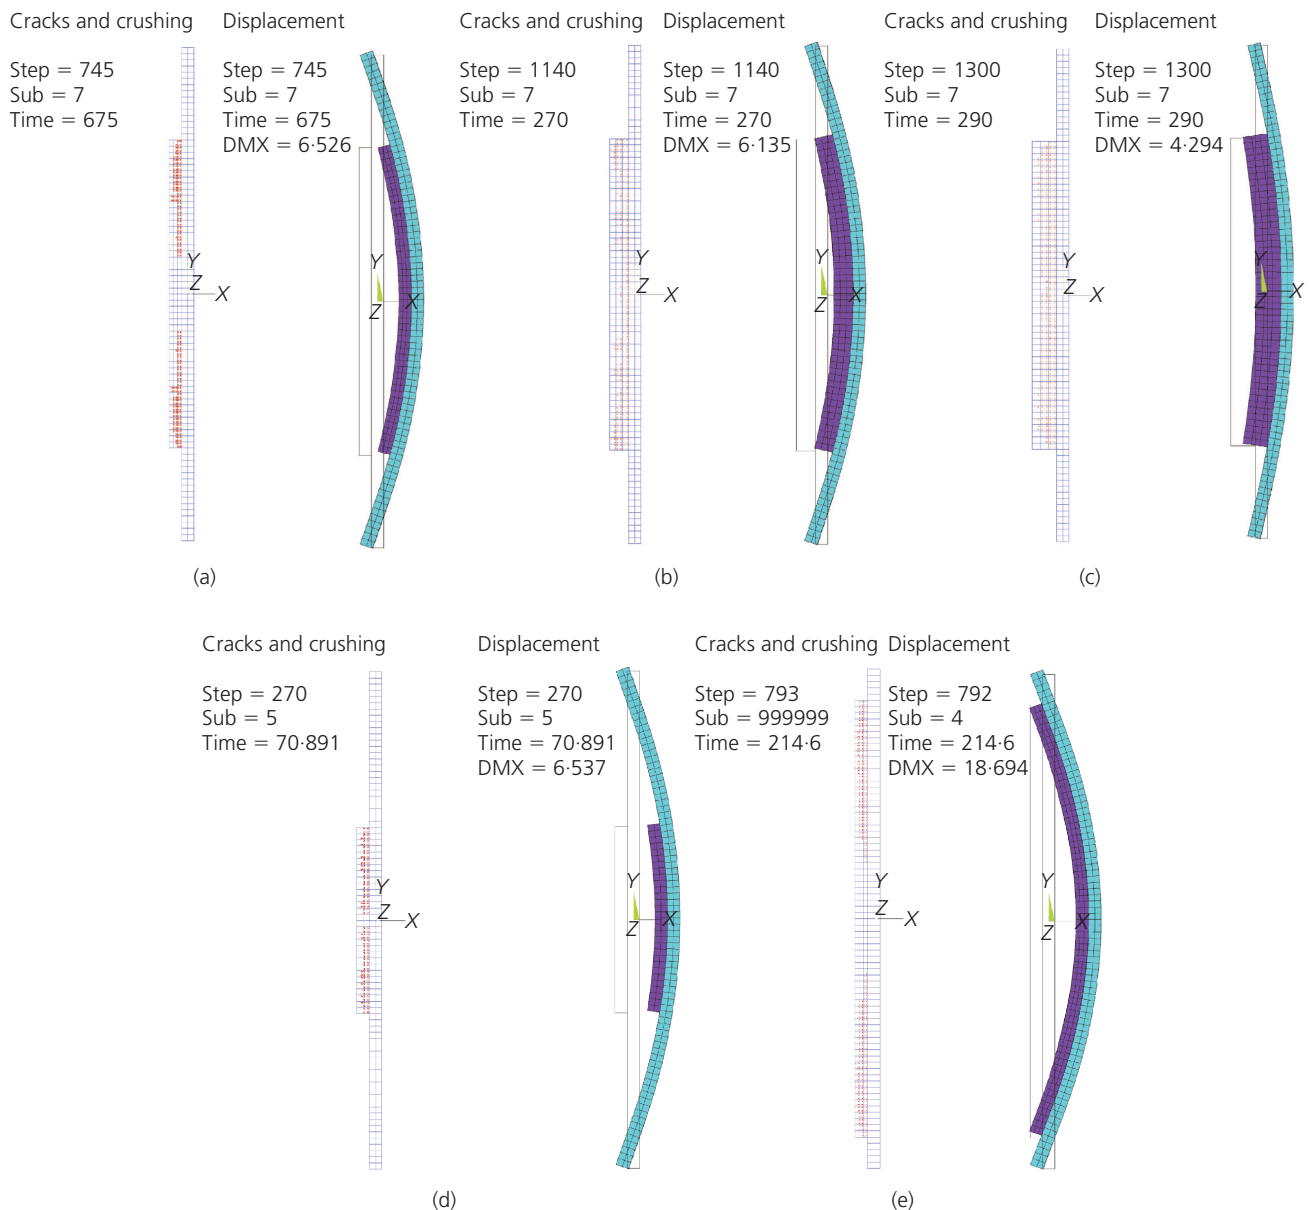
Figure 15. Comparison of damage mechanisms and final deformed shapes of different cases on compression side
(a) $500 \times 60 \times 20$; (b) $500 \times 60 \times 30$; (c) $500 \times 60 \times 40$;
(d) $300 \times 60 \times 20$; (e) $700 \times 60 \times 20$
